Weston & Sampson

REPORT

Engineering Evaluation & Design Alterative Analysis

CITY OF
Peabody
MASSACHUSETTS

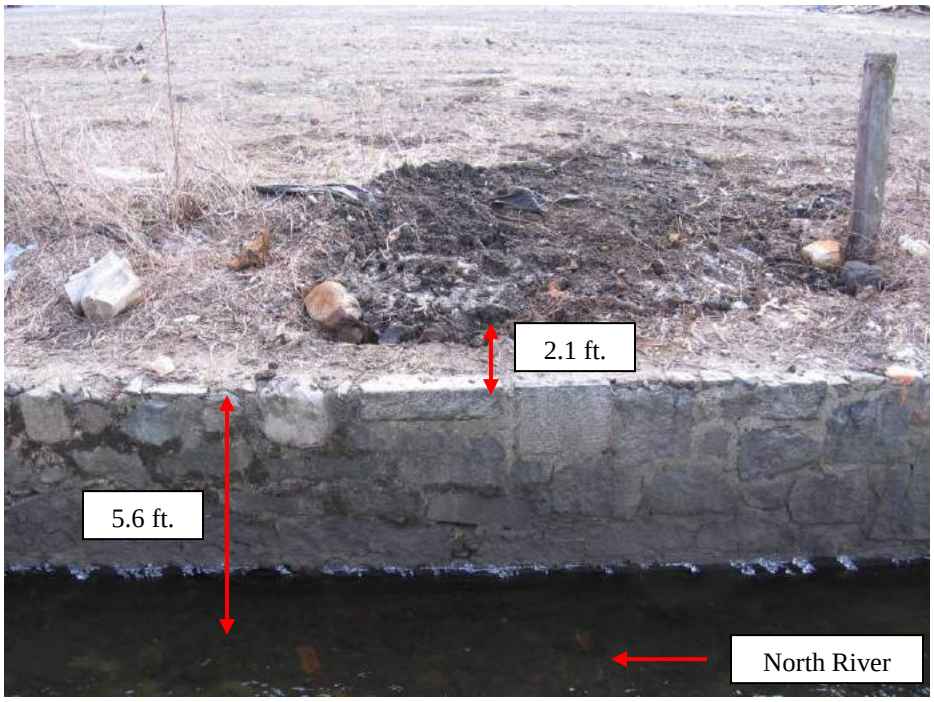
TEST PIT #5

The face of the mortared granite wall at this location (1 of 3)

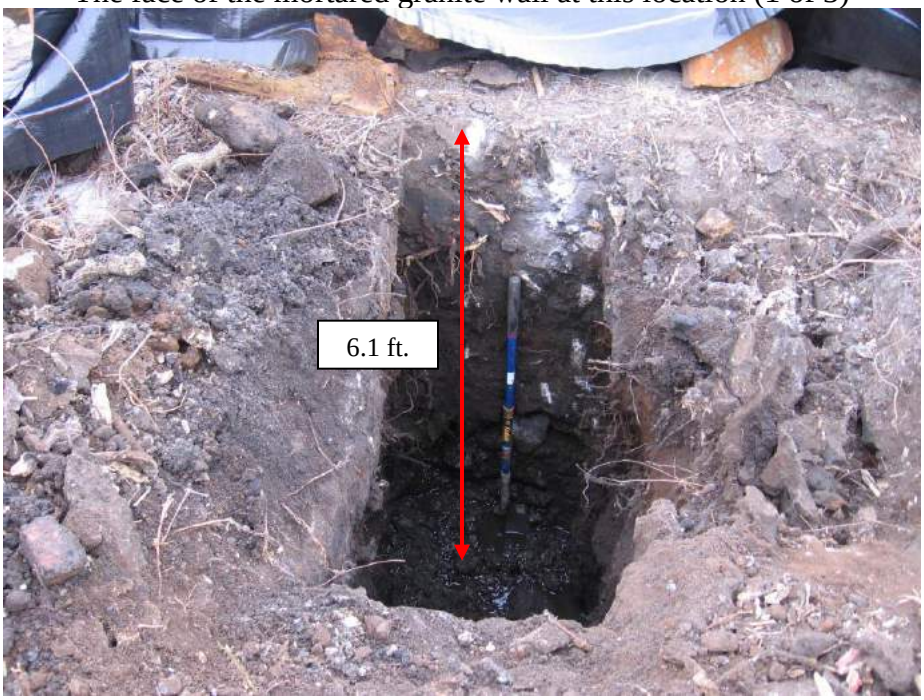
The mortared, vertical back of the granite wall looking towards the North River (2 of 3)

The vertical backside of the mortared granite wall looking upstream (3 of 3)

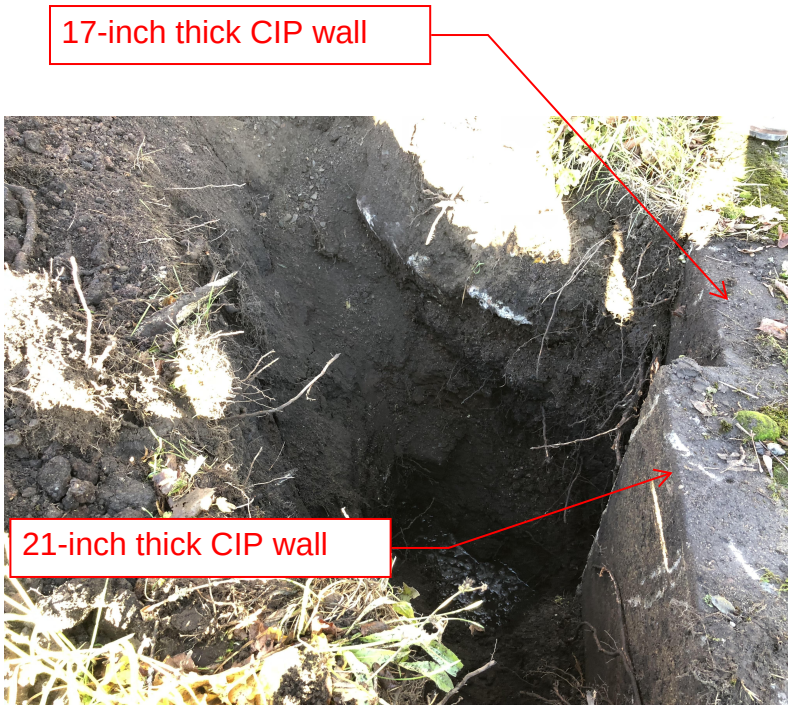
Photo 1 - Overview of TP-2.

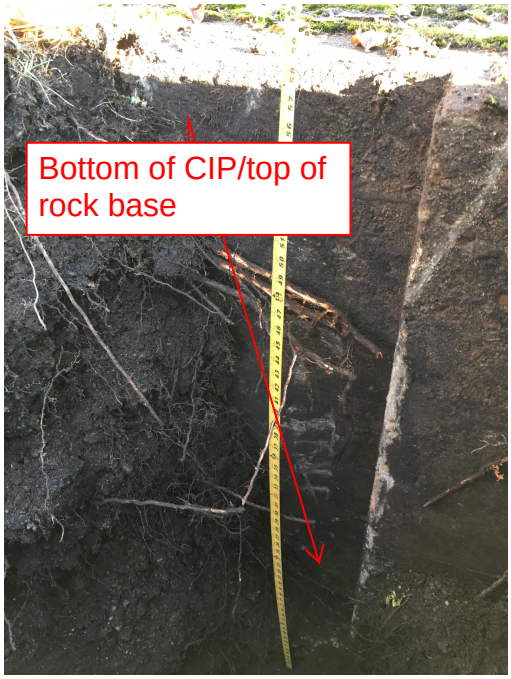
Photo 2 - Concrete wall and rock base.
